Headley Roads Survey

Headley Parish Council
December 2020

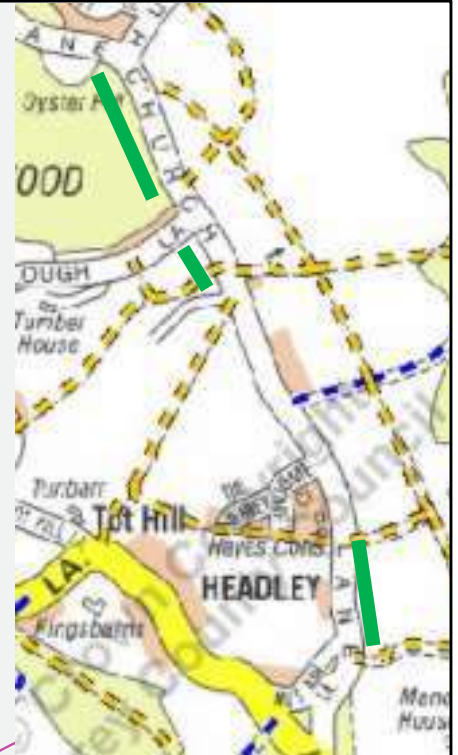
Church Lane - overview

- significant challenges with 2 blind summits (by Springfield and opposite Church Approach)
- Northern and Southern ends both marked by bendy sections where high banks limit visibility

- This is part of the bus route
- Cyclists travel fast Northbound, unaware of hidden entrances, and slowly on uphill sections Southbound delaying faster vehicles approaching summits; Section from Hurst Lane to Slough Lane forms part of Sustrans cycling route 22
- The section is well used by horses coming from Hurst Lane (North East), Slough Lane (West), Costal Wood bridleway (East) and Headley Heath (South East & South West)

- Includes access to Church (off Church Approach), pub, village shop and village hall
- No pedestrian footway on section past The Cock
- Pedestrian footpath towards Southern end suffers from mud thrown up from pools where water collects have come down the road off Headley Heath

- Restrict speed limit on Hurst Lane
- Additional signing to warn of horse-crossing
- Move existing horse-warning sign to Clay Lane to give advance warning

- Possible speed warning post – however not a good position as there is little speeding at this point

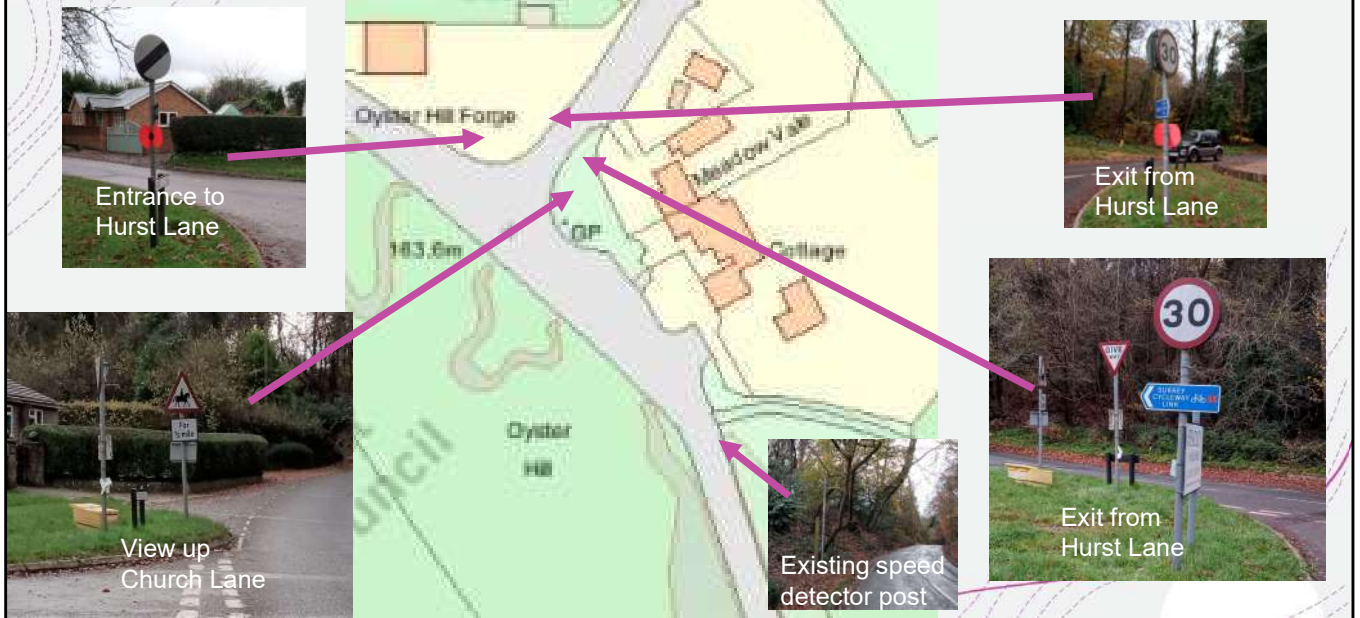
Church Lane/ Hurst Lane junction signs

- Hurst Lane is derestricted; even so it is well-used by horse riders as it provides access to various stables
- A major pinch-point on Clay Lane immediately to the North-West causes regular congestion when the bus (or an HGV) meets oncoming traffic
- Was the site of a cycling fatality in 2020 – apparently not related to other traffic

- Junction suffers from excessive clutter of signs
- Notable that the horse-warning sign (for Southbound traffic) comes immediately AFTER a major horse crossing point

- Junction can be a regular assembly point for cyclists
- Cyclists heading Southbound are slowed down by the steep hill; the poor visibility makes overtaking very difficult

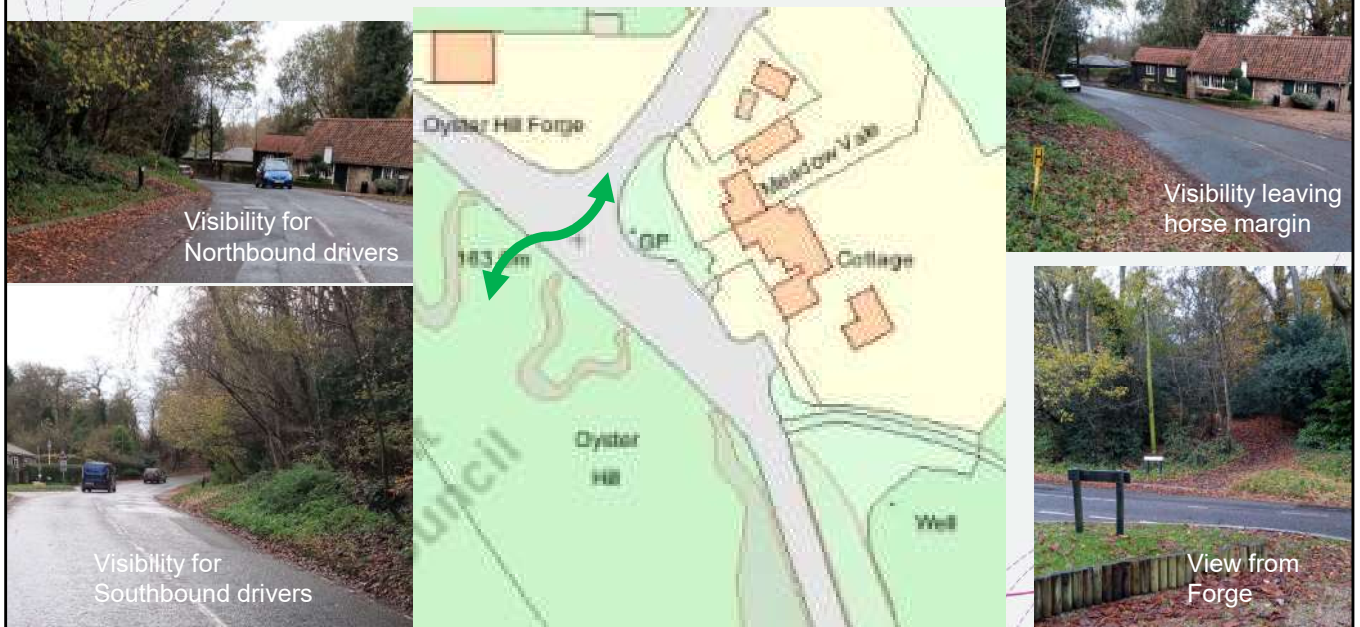
Church Lane/ Hurst Lane horses

This is a major crossing point for horses coming from Hurst Lane to reach the horse-margin which provides an off-road route to the South

- Driver's visibility of horse margin from either direction is somewhat limited
- Rider's visibility of Clay Lane from the horse-margin is also restricted by the shape of the hill
- Note the horse margin involves a steep descent to the road
- Despite the presence of the horse-margin, some regular horse-riders prefer to ride in the road up the hill Southbound. It may be that they are put off by the steepness of part of the horse-margin, but this adds a further problem for drivers

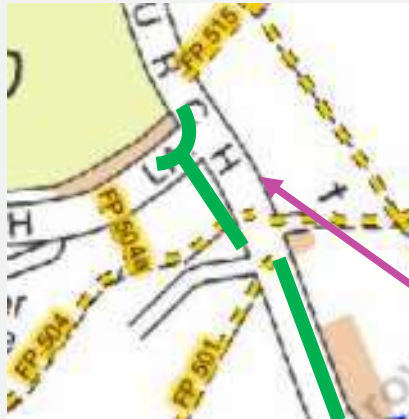
Church Lane/Slough Lane

- Horse traffic from Slough Lane
- Horses (& pedestrians) forced into road alongside The Cock

- Blind summit by Church Approach
- Warning signs obscured by vegetation
- Slow cyclists travelling Southbound
- Cyclists using Slough Lane – Sustrans Route 22

- Specific warnings of horse-crossings
- Ensure signs are not obscured by vegetation

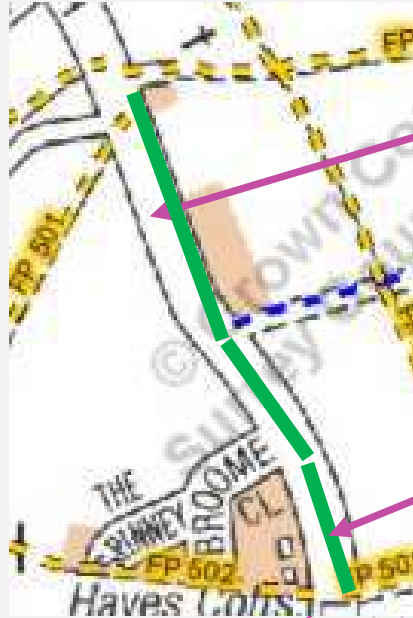
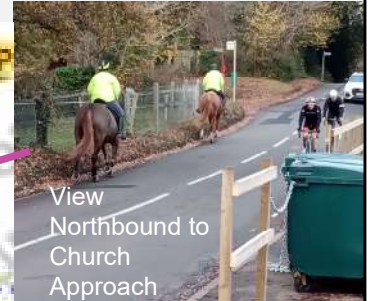
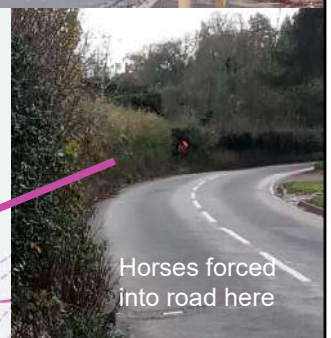
Church Lane/pub & shop - overview

- Generally good visibility leads to regular speeding
- Church Approach blind summit
- Poor visibility exiting from Threshers Dean
- No footway beside The Cock
- Horses forced onto road for entire length, incl bend at Southern end

- Visibility generally good – problem with regular speeding
- Blind summit at Church Approach
- No footway beside The Cock
- Horses forced onto road for entire length

- Specific warnings of horses/pedestrians in road
- Upgrade speed detection/warning sign(s)

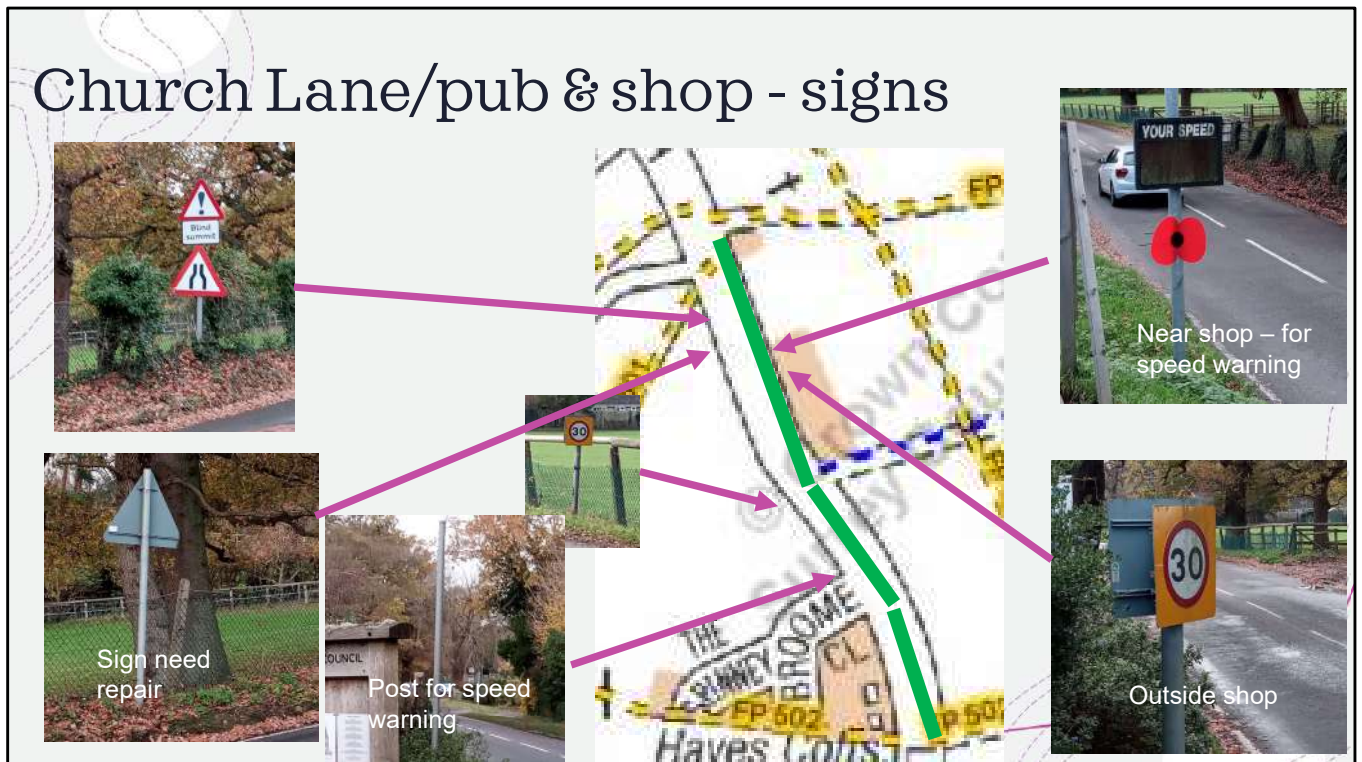
Church Lane/pub & shop - signs

- Existing post just North of shop has non-functioning speed warning sign
- Sign giving advance warning of right-hand turn (Church Approach) needs re-orientation

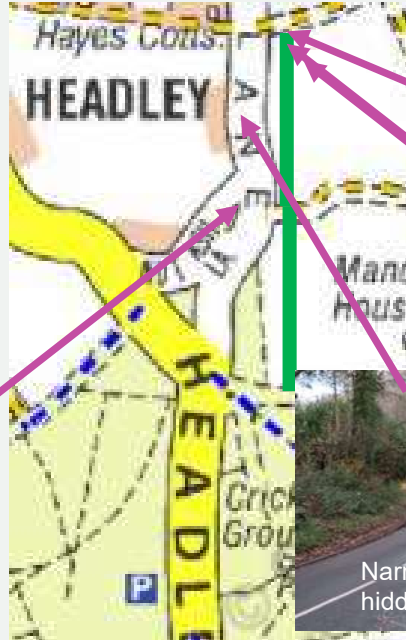
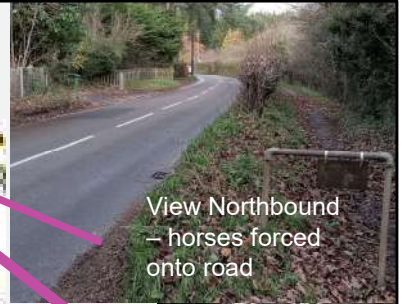
Church Lane South- overview

- Horses cross towards Heath
- Very poor visibility
- Speeding cyclists
- Hidden entrance
- No footway to Villans Wyk

- An narrow section of road with visibility limited by high banks
- Hidden entrance to Villans Wyk
- Northbound cyclists speed up downhill; Southbound cyclists slow uphill
- Nut Ash Lane entrance complicated by:
 - Limited visibility Southbound
 - Horses crossing to go towards Heath
 - When congested, traffic turn right out of Nut Ash Lane to avoid main junction

- Upgrade speed detection/warning
- Request no right turn out of Nutash Lane

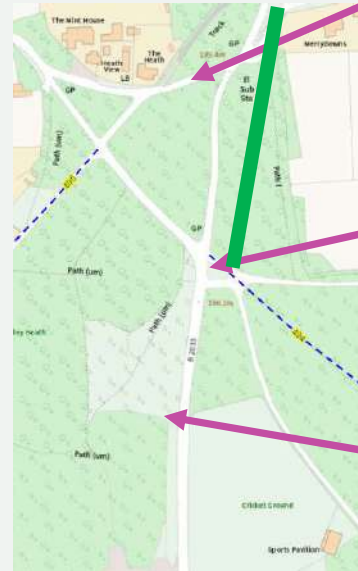
Heath & Nut Ash Lane

- Limited visibility at both ends of Nut Ash Lane
- Nut Ash Lane used as rat run to avoid queues on Leech Lane – dangerous right-hand turn onto Church Lane
- NT car park generates traffic at busy periods
- HGV sign encourages traffic down Church Lane
- Bridleways not fully connected

- Nut Ash Lane is well-used but narrow & poses various issues
 - Limited visibility at Eastern end (Church Lane)
 - When congested, traffic turns right out of Nut Ash Lane to avoid main junction
 - Horses crossing to go towards Heath
 - At Western end most traffic needs to turn right but has limited visibility Northbound, due to proximity of bend & Southbound due to angle of junction and vegetation on verge
- Leech Lane/Church Lane junction is complicated by side-roads
- Unnecessary HGV sign encourages traffic down Church Lane
- NT car park generates significant traffic
- Cricket pitch can act as distraction
- Traffic often speeds across Headley Common Road

- Upgrade speed detection/warning
- Request no right turn out of Nutash Lane
- Ensure NT keep vegetation down at Western end of Nut Ash Lane

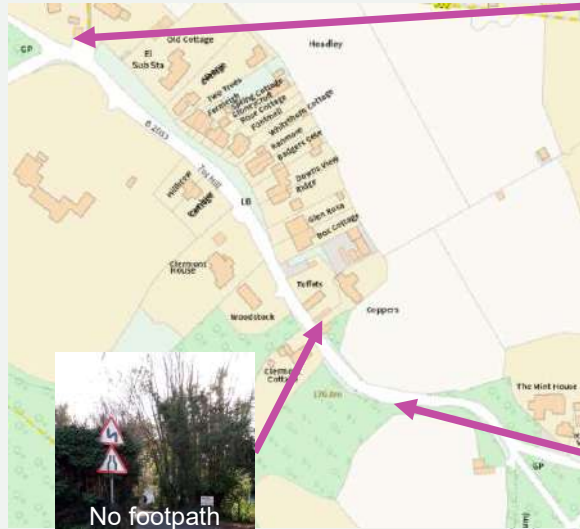
Tot Hill

- Speeding cyclists
- Poor visibility & no footway at Southern end
- Relies on verge as footway
- Sharp bend at Northern end
- Ice risk at Northern end due to leaf blockage on gulleys

- As a key residential road, there are several cars parked on driveways adjacent to the road
- It relies on use of the verge as a footway but is not connected either at the Southern end towards Mint House, or at the Northern end towards Hyde Farm
- Predominant cyclist direction is downhill – so many go at high speeds
- The sharp bend at Northern end can become an ice risk in winter due to leaf blockage on gulleys
- Cars for sale provide driver distraction at Northern end

- Install speed detection/warning
- Look at footpath improvements

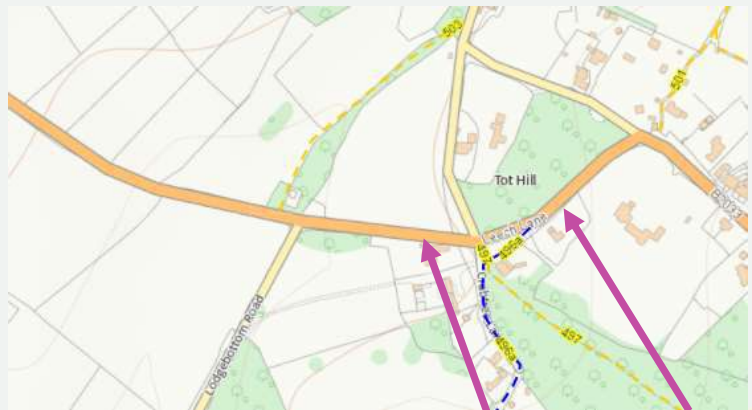
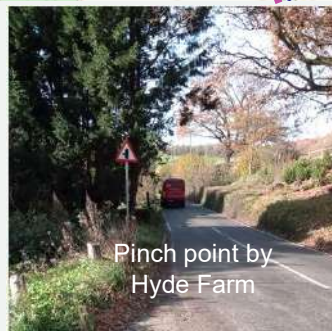
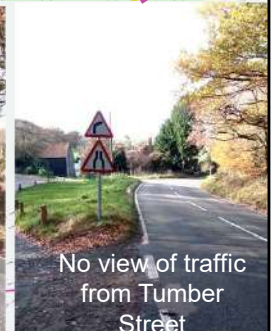
Hyde Farm area

- Very poor visibility on exit from Tumber Street
- Equestrian (& pedestrian) crossing to bridleway on Crabtree Lane
- No footpath to Tot Hill
- Pinch point for larger vehicles
- Speeding cyclists

- Crossing between Tumber Street & Crabtree Lane
 - Significant use by vehicles (SatNav rat-run), equestrians (route to Heath) & cyclists (Sustrans route 22)
 - Very poor visibility splays existing Tumber Street due to slopes & curve in road
 - Traffic leaving Headley tends to accelerate downhill (especially cyclists)
- No marked footpath to Tot Hill
- Hyde Farmhouse causes pinch-point for larger vehicles
- Some cyclists take Lodgebottom Road turning at excess speeds

- Warning sign for crossing traffic

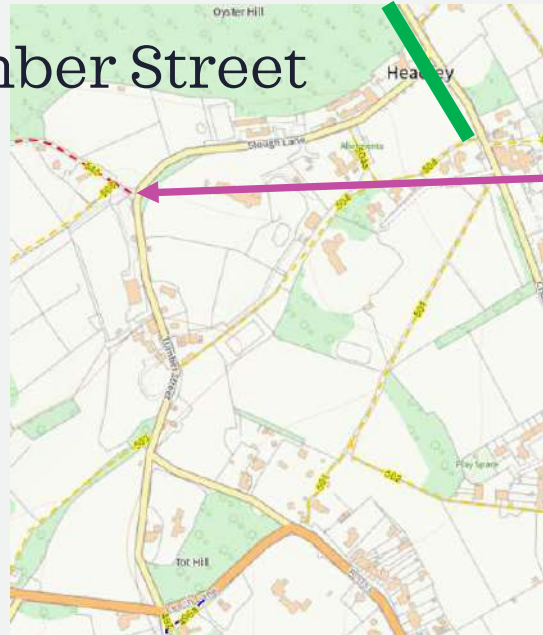
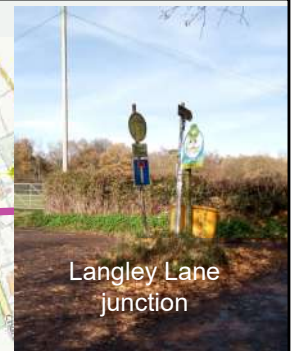
Slough Lane, Tumber Street

- Very narrow roads – limited passing places even for pedestrians!!
- High equestrian use for local stables and as key link in network
- Signed cycle route
- Used as SatNav rat-run – even by HGVs

- Very narrow roads
 - limited passing places - even for pedestrians!!
 - Cars need to reverse if they meet
- High equestrian use for local stables and as key link in network
- Signed cycle route – Sustrans 22
- Used as SatNav rat-run – even by HGVs
- Langley Lane (BOAT) has appeared on some SatNavs – even for HGVs

- Signage at entrance as single-track road
- Influence SatNav algorithms (?speed limit?)

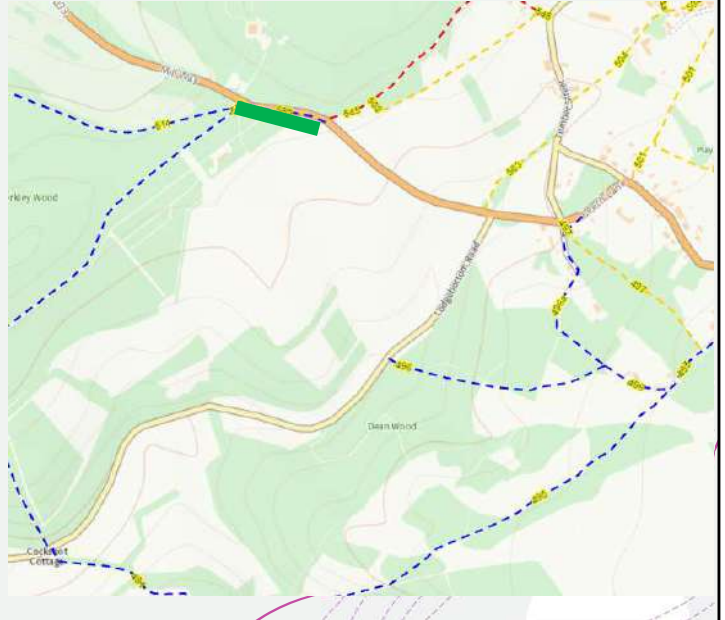
Mill Lane, Lodgebottom Road

- Unrestricted speed limits:
 - Uphill cyclists cause delays
 - Downhill cyclists speed
- Section through golf course has 4 well-used pedestrian crossings
- Key horse crossing point facilitated by horse margin South of road
- Nower Wood Education Centre can act as traffic generator
- Hedges alongside Lodgebottom Road can reduce visibility and road width

- Introduce 40 mph blanket speed limit
- Markings for horse-crossing

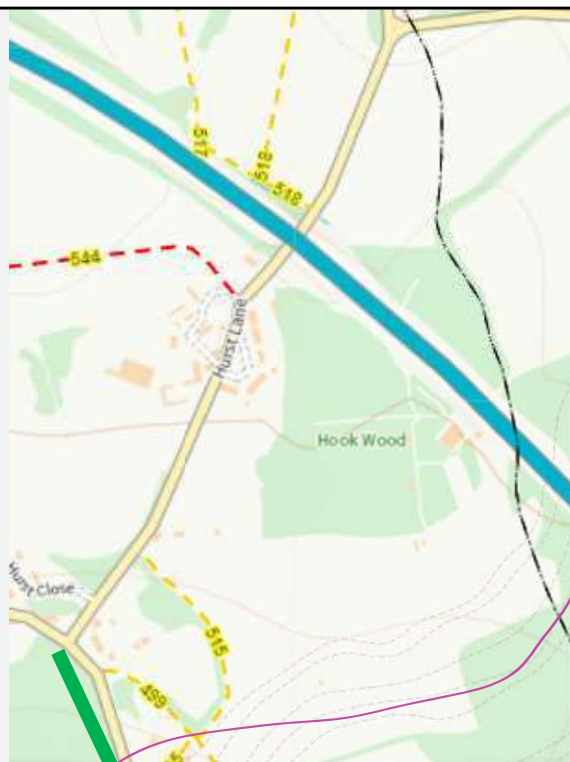
- Unrestricted speed limits
- Part of marked Sustrans cycle route
 - Cyclists stopped at Church Lane junction often cause obstruction for traffic existing Hurst Lane
- Well-used by horses to service several stables and provide access to permissive bridleway to village centre
- Visibility restricted around Hookwood Cottages

- Unrestricted speed limits; some places difficult to pass
- Part of marked Sustrans cycle route
 - Cyclists stopped at Church Lane junction often cause obstruction for traffic existing Hurst Lane
- Well-used by horses to service several stables and provide access to permissive bridleway to village centre
- Visibility restricted around Hookwood Cottages

- Introduce 40 mph blanket speed limit
- Warnings re horses

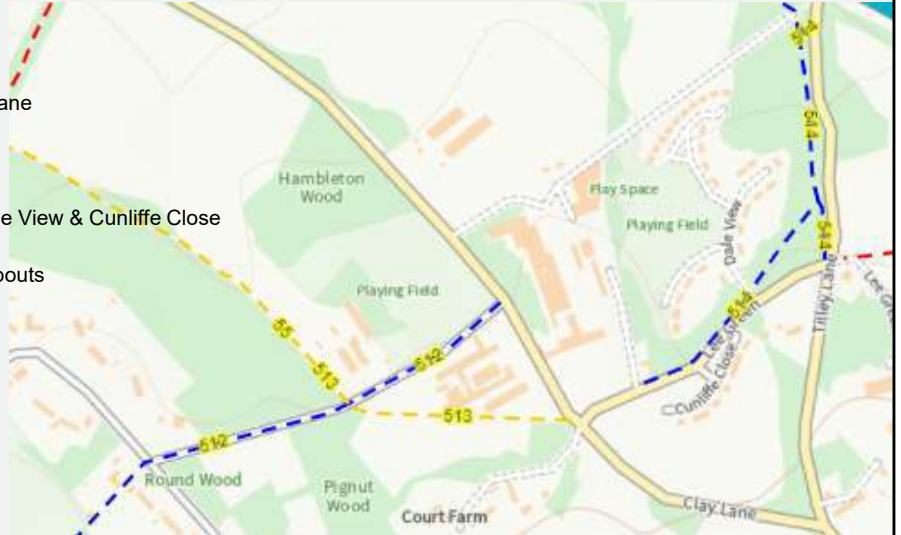
Headley Court area

- Narrow with major wet-spot
- Poor visibility at Tilley Lane junction

- Winding section between high banks
- Dangerous junction with Lee Green Lane

- Poor visibility generally
- Wet-spot opposite Cunliffe Close
- Higher traffic due to occupation of Dale View & Cunliffe Close

- Narrow section between mini-roundabouts
- Heavily used by horses
- Impact of new developments

- Headley Court redevelopment
 - Already seeing increased vehicular use following re-occupation and significantly more vehicles at Dale View & Cunliffe Close
 - Further increases likely as new developments are undertaken
 - Temporary increase in HGV traffic for construction work
- Clay Lane
 - Narrow with major wet-spot
 - Poor visibility at Tilley Lane junction
- Tilley Lane
 - Winding section between high banks
 - Dangerous junction with Lee Green Lane
- Lee Green Lane
 - Poor visibility generally
 - Wet-spot opposite Cunliffe Close
 - Higher traffic due to occupation of Dale View & Cunliffe Close
- Headley Road
 - Narrow section between mini-roundabouts
 - Heavily used by horses

- Recognition of wetspot on Clay Lane – drainage solution possible into adjoining field
- Recognition of wetspot in Lee Green Lane – less obvious solution
- Introduce 40 mph blanket speed limit
- Warnings re horses by Headley Court mini-roundabouts
- Warnings re horses at Lee Green Lane/Tilley Lane

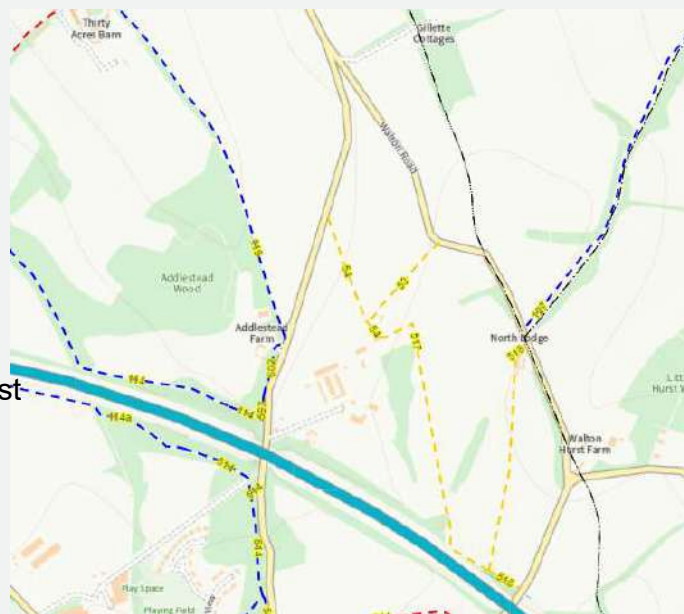
Loretta Lodge area

- Wet spots in heavy lane
- 40 mph speed limit often exceeded
- Surface at edges recently improved

- De-restricted speed limit
- Very narrow with limited passing places
- Part of Sustrans 22 cycle route
- Well used by horses
- Problems with parking for Woodland Trust wood

- Very narrow with limited passing places
- Part of Sustrans 22 cycle route
- Well used by horses
- Problems with parking for Woodland Trust wood

- Introduce 40 mph blanket speed limit on Walton Road
- Warnings re horses by North Lodge

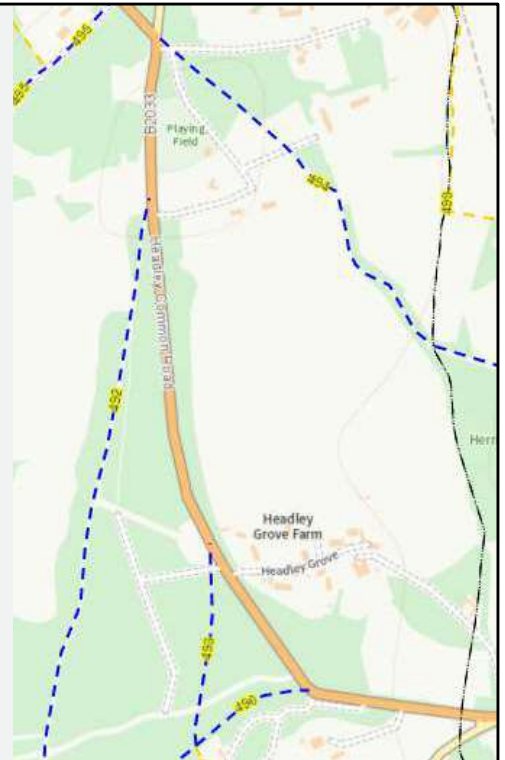
- 40 mph speed limit – frequently exceeded
- Well-used NT car parks
- Deceptive bend at Southern end – many vehicles crash into fence panels by entrance to Boidier
- Major risks due to poor visibility at right-hand turn at Pebblecombe Hill – in adjoining Reigate & Banstead

- Work with neighbouring areas on Pebblecombe Hill junction
- Speed warning signs (40 mph) on Headley Common Road
- Signage/road markings near bend at Southern end
