Headley Roads Survey

Headley Parish Council
December 2020

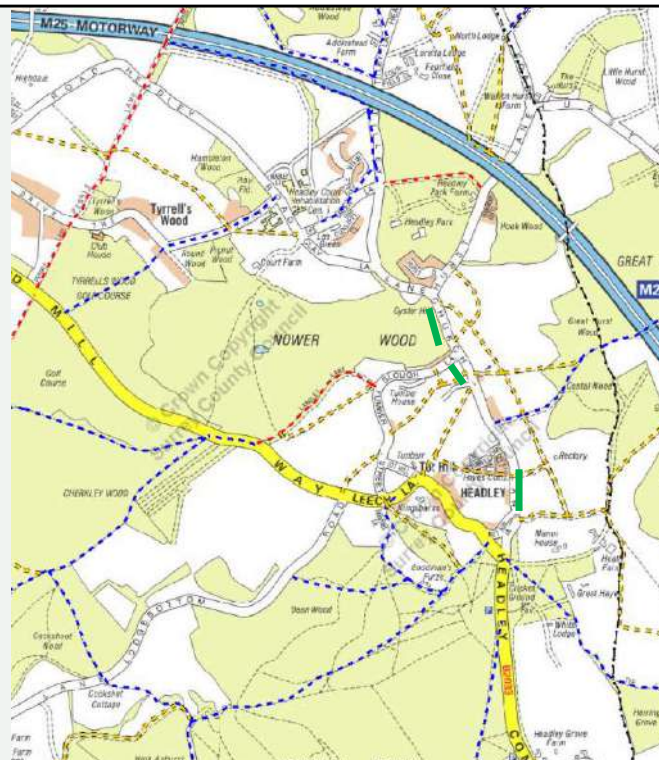
Church Lane - overview

Geography:

- Blind summit at Church Approach
 - Visibility restricted at South & North by high banks
- ## Horses
- Significant horse traffic from Hurst Lane, crossing to Oyster Hill horse margin and from Slough Lane
 - Horses forced to use road along central section

Other

- No footway alongside The Cock
- No footway to Villans Wyk
- Busy cycling route with hidden entrances
- Sustrans Route 22 from Slough Lane to Hurst Lane
